Docket No. 217 – Development and Management Plan Inspection

Northeast Utilities Service Company Certificate of Environmental Compatibility and Public Need for the construction of a 345-kV electric transmission line and reconstruction of an existing 115-kV electric transmission line between Connecticut Light and Power Company's Plumtree Substation in Bethel, through the towns of Redding, Weston, and Wilton, and to the Norwalk Substation in Norwalk, Connecticut.

Date: June 29, 2005

Location: Norwalk Substation Expansion

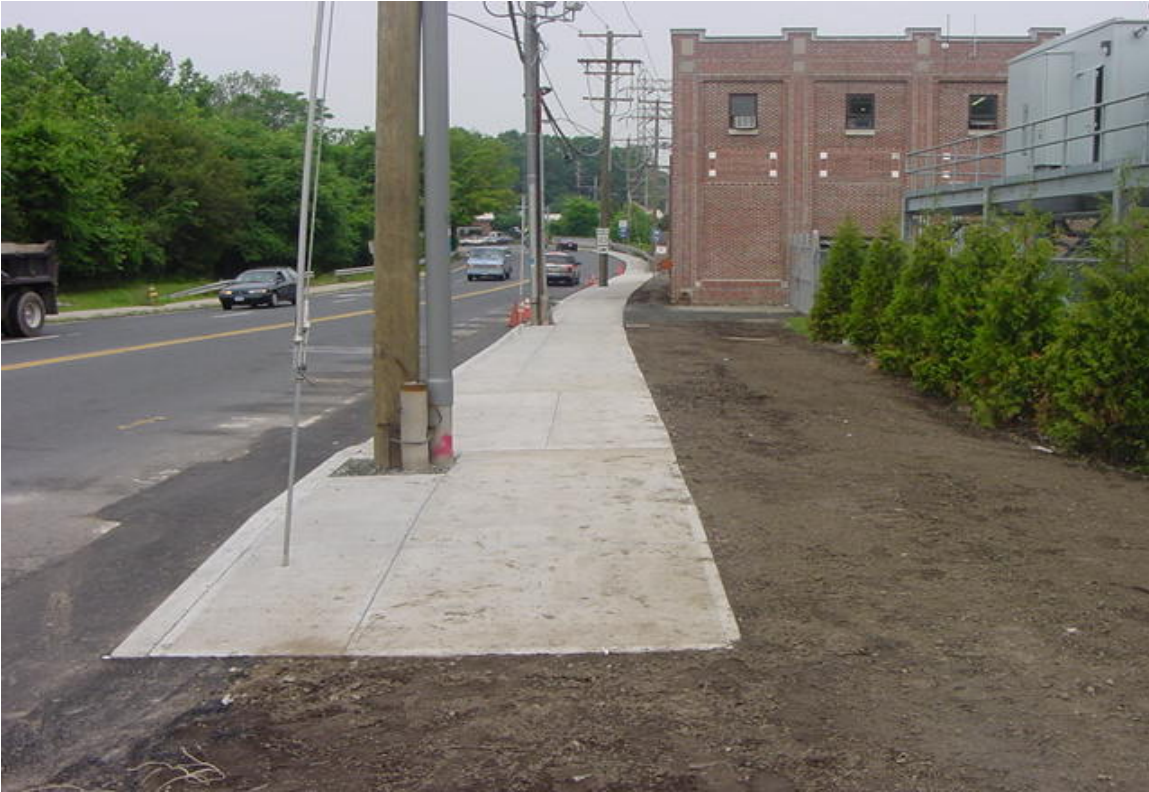
Areas of Inspection	Observation	Recommended Action
Access Roads and Adjacent Roadways	<ul style="list-style-type: none"> - The area surrounding the inlet near the Route 7 ramp has been placed with stone to cover the roots of the exposed planting and to repair the erosion issues here. 6/29/05 - The concrete sidewalk along New Canaan Ave is now complete. Final stabilization or cover will be needed in the area adjacent to the work. 6/29/05 	<ul style="list-style-type: none"> -The area has been stabilized with stone and the roots of the planting have been covered. The area should be monitored to make sure it is now stabilized. 6/29/05 - The sidewalk is completed and some adjacent bare soil areas remain. The soil should be hydroseeded if activities are complete. 6/29/05
Foundation construction	<ul style="list-style-type: none"> - Soil from the stockpile was being used around the GIS building, including some small excavation and backfill areas near the back of the building. 6/22-6/29/05 -Masonry work on the structures in front of the GIS building as well as work within the foundation area is ongoing. 6/15-6/29/05 - Another small area of excavation is ongoing just within the live yard near the sidewalk installation. 6/22-6/29/05 	<ul style="list-style-type: none"> - None at this time. 6/29/05 - All excavation and backfill work is well within the yard and areas are contained, no issues at this time. 6/29/05

Norwalk Substation- Completed concrete sidewalk in front of the site on New Canaan Ave. 6/29/05

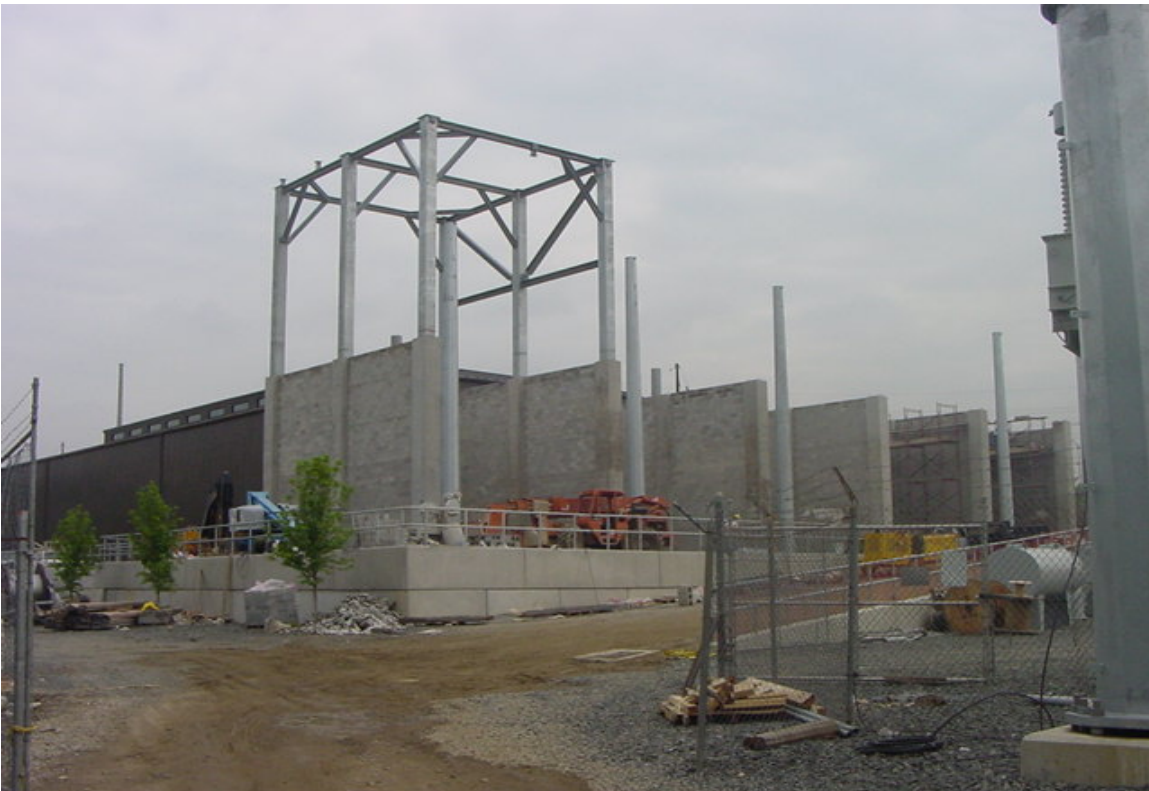
Masonry work continuing in front of the GIS building. 6/29/05

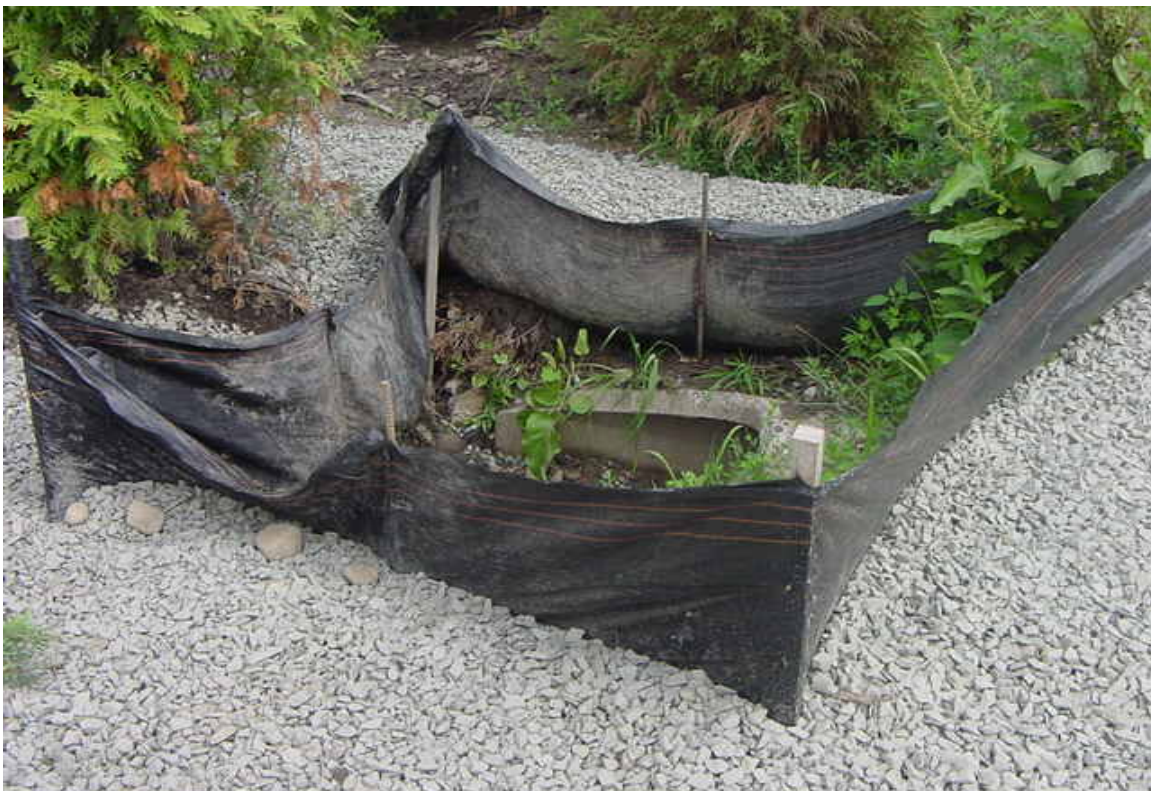
- The area surrounding the flared inlet near the Rt 7 ramp has been placed with stone to prevent erosion from the large amounts of stormwater from the ramp as well as portions of the perimeter of the site. 6/29/05 - The exposed root ball of the planting was also covered in soil and stone. 6/29/05 - Topsoil was placed along the new sidewalk. 6/29/05	- Continue to monitor the area to determine if the new efforts have stabilized the inlet . 6/29/05

Stone has been installed around the inlet near the Rt. 7 ramp to repair the exposed tree roots and the erosion problems. 6/29/05

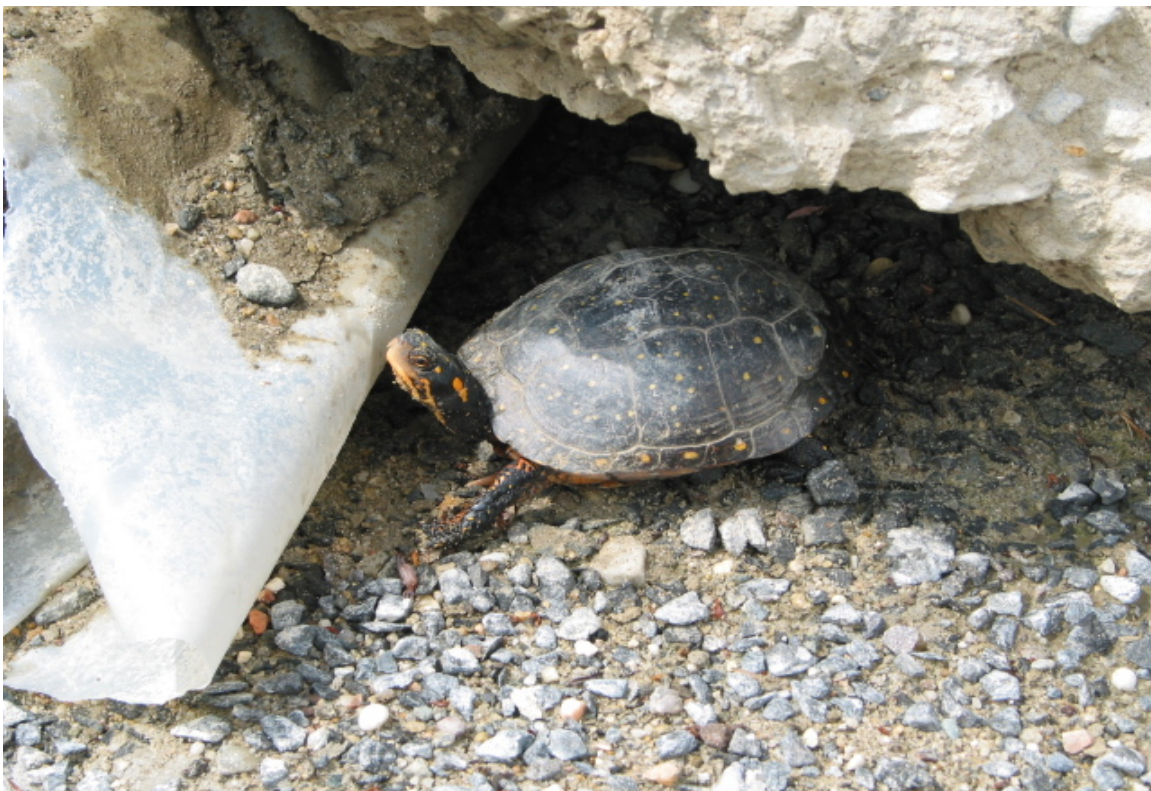
Areas of Inspection	Observation	Recommended Action
	- A majority of the soil has been removed to appropriate off-site locations but some will remain on an as needed basis for the remainder of construction. They are not covered in plastic but are well within the site. 3/2-6/29/05	-Continue to monitor status and cover stockpiles with plastic if necessary. 3/2-6/29/05
Inland Wetland and Watercourse encroachment and mitigation	- Wetlands are located around the outskirts of the substation yard. The work within the substation yard has caused no observed sedimentation. 6/29/05	- The stone berm around the perimeter of the yard continues to prevent sedimentation and water from leaving the site and getting to the wetland edge. 6/29/05
State species of concern, threatened and endangered species	-The sand pile with the potential nest has been surrounded with safety fence and does not need to be moved or disturbed for several months. 6/15-6/29/05 - A spotted turtle (<i>Clemmys guttata</i>) was also located within the substation and moved outside the fence. This species is not listed as special concern in the state of CT. 6/29/05	- Everyone at the substation also remains aware and will move machinery carefully in case the individual turtle returns. We will continue to monitor the nest, especially in the late summer. 6/15-6/29/05.

A spotted turtle (*Clemmys guttata*) has now been observed on site. This species is not listed for special concern in the state of Connecticut.
